ELMVILLE DAM
CT 00165

PHASE I INSPECTION REPORT
NATIONAL DAM INSPECTION PROGRAM

Identification No.: CT 00165
Name of Dam: Elmville Dam
Town: Killingly
County and State: Windham County, Connecticut
Stream: Whetstone Brook
Date of Inspection: 21 August 1979

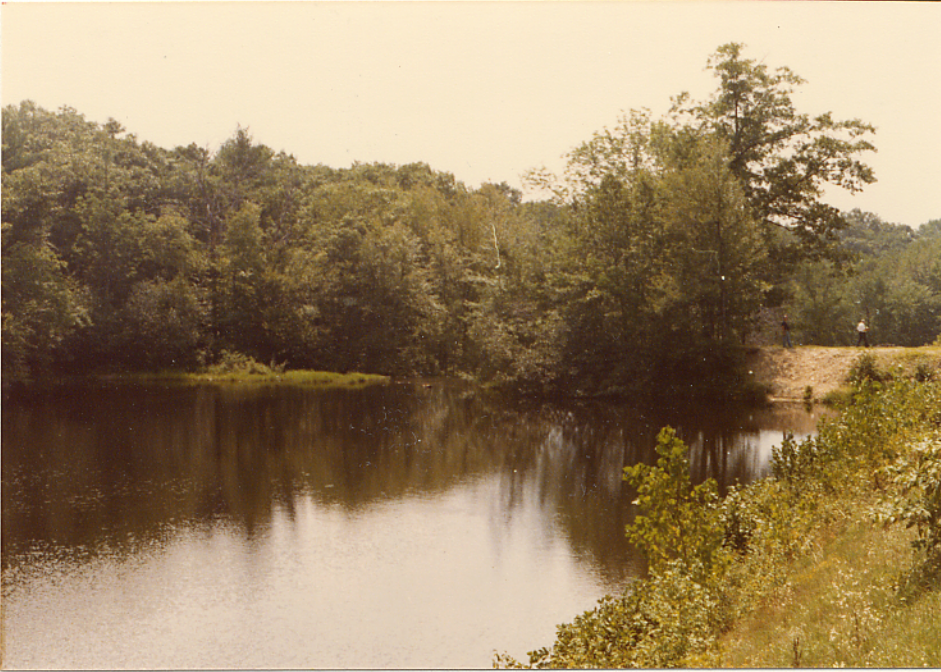
Overview from upstream, showing overflow section left, earth dike right.

(1) Spillway. The masonry overflow section was in good condition, considering its evident age and the type of construction. There are training walls located at each end of the overflow section which are constructed of laid up masonry. On the south (left) side of the spillway the training wall joins directly to outcropping rock (Appendix C, Photo No. 2). The north (right) training wall is not intact, and the once retained dike embankment in that area had eroded on the upstream side. The crest of the spillway is constructed of 8 ft. long capstones which have settled a minor amount. Siltation has taken place upstream of the dam and was up to the crest of the spillway on the left side, supporting luxuriant vegetation (Overview Photo No. 1).

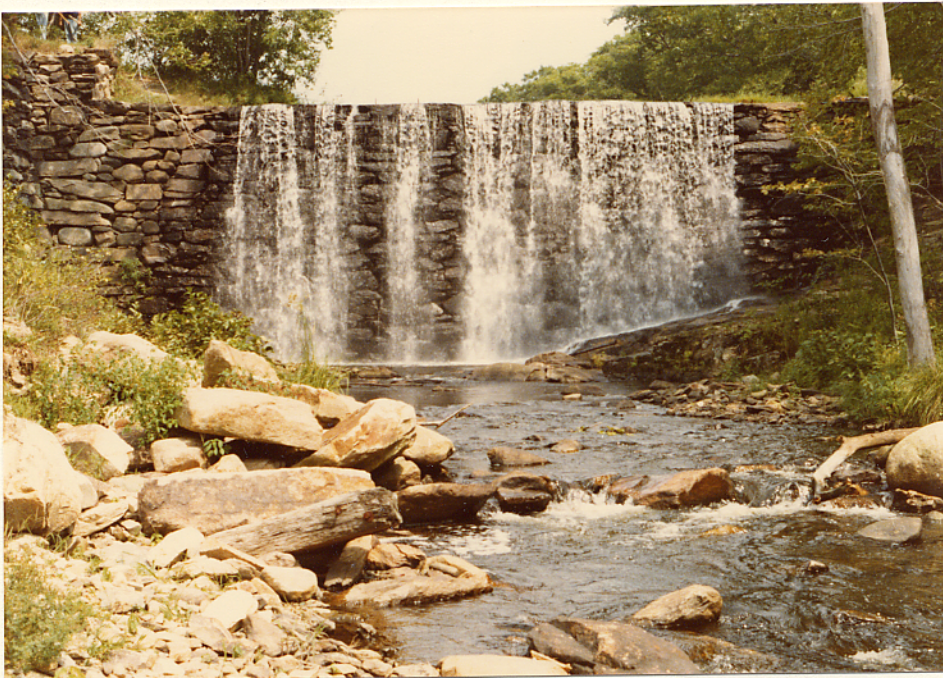
Overview of overflow section from downstream.

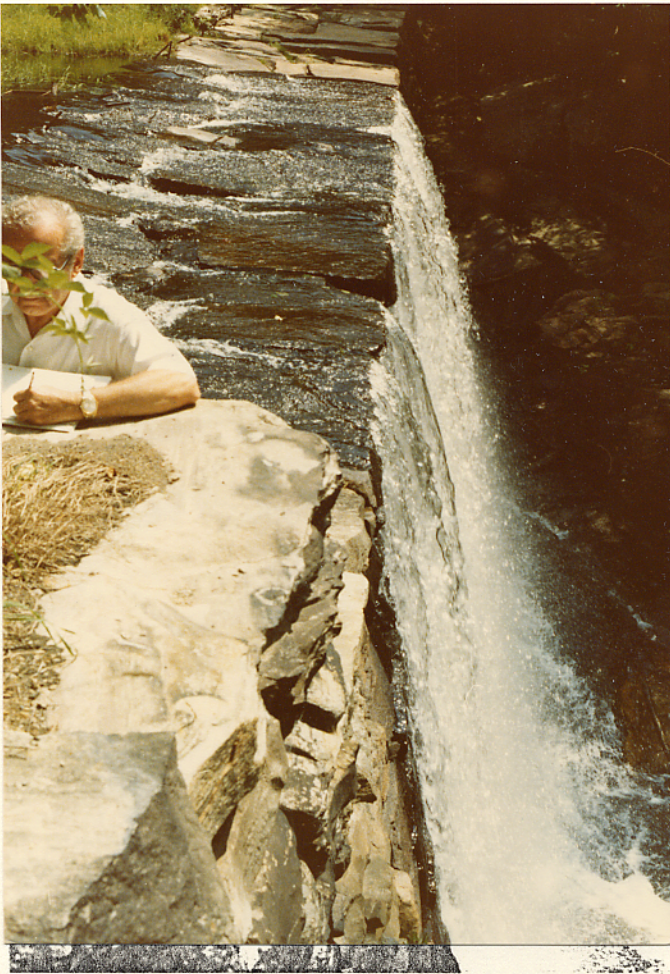
1. Crest of
overflow section

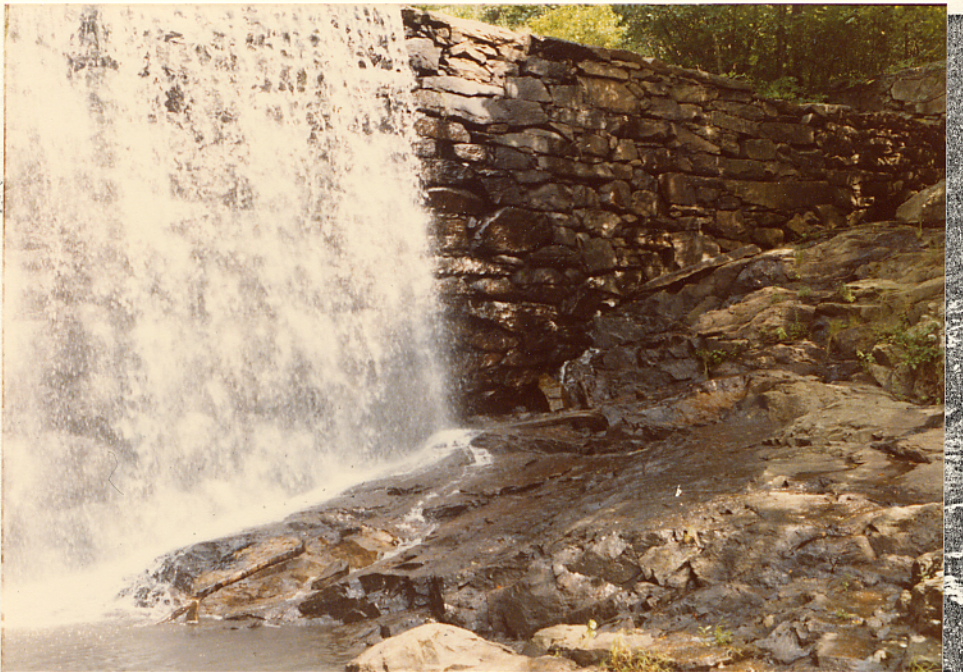
2. Ledge rock outcrop at left end of overflow section.

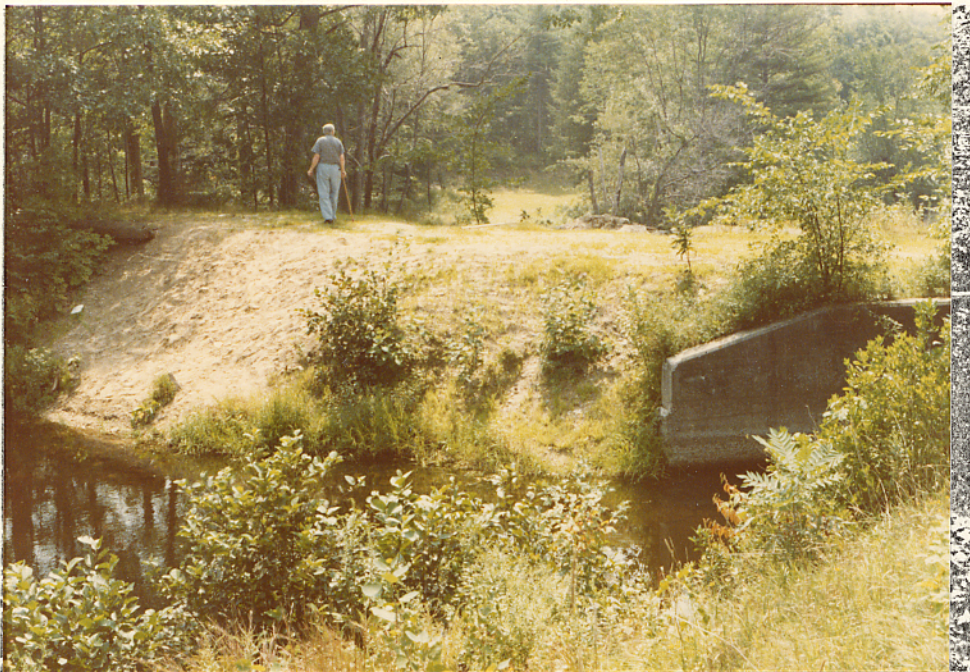
(2) Dike. The general condition of the earth dike appeared to be fair. The earth embankment was heavily overgrown on the upstream and downstream face with many mature trees (Appendix C, Photo No. 3). A 20 in. dia. cast iron pipe section of a 21 in. dia. sewer line has been constructed through and beneath the embankment in recent years, as shown on the drawing in Appendix B. No seepage cut-offs are shown on the plans and the types of backfill materials within the excavation through the embankment cannot be ascertained from the drawings. At mid-embankment, massive rocks have been randomly dumped on the downstream slope of the dam, and may be associated with the sewer construction (Appendix C, Photo No. 4). No riprap appears to be present on the upstream face of the embankment. The materials of the embankment, at least in the vicinity of the back-filled zone of the sewer, were granular and quite permeable to a depth of at least 1 foot. It was estimated that less than 10% of the material would

3. Upstream face of earth dike and diversion channel entrance at right abutment.

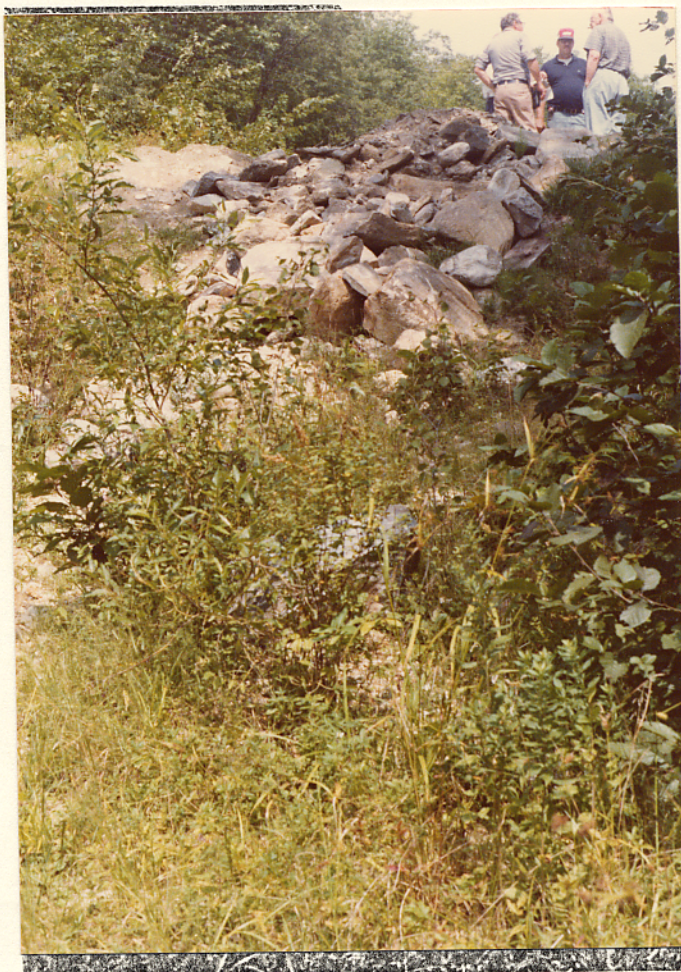
4. Downstream slope of earth dike showing dumped rock.

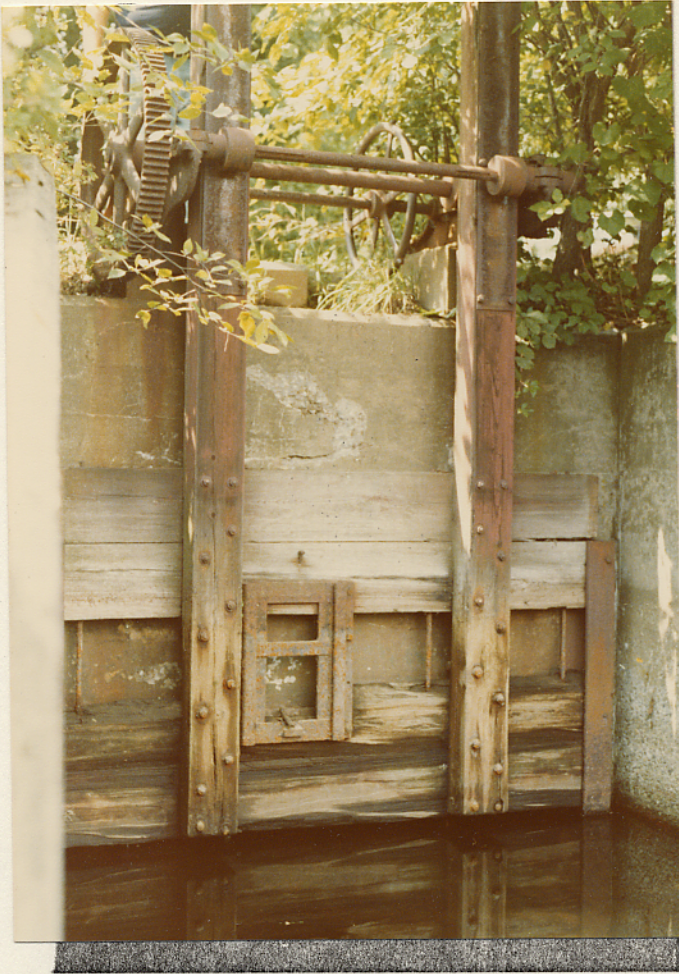
(3) Diversion Canal and Headworks. The old mill canal passes through the right end of the earth dike, via a concrete headworks. The concrete was in fair condition, with some spalling and surface deterioration. The single wooden gate in the headworks appeared to be in fair condition and the operating mechanism seemed to be intact, but was not operative (Appendix C, Photo No. 5). Just downstream of the embankment the canal is totally obstructed with demolition debris and no flow appears to be passing through the gate.

5. Diversion canal headworks gate.

(5) Study the engineering implications of restoring the overflow canal and gate structure to an operating condition.

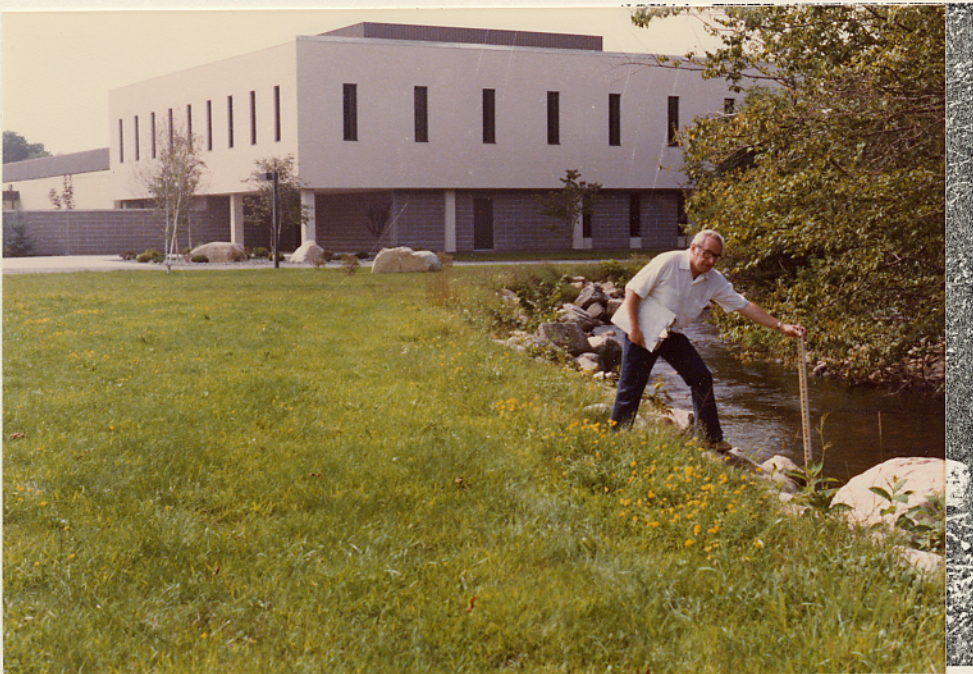
Below Route 12, the stream channel is only about 10 ft. wide and 3 ft. deep. The CEM complex is located close to the brook and would probably sustain some flood damage before failure of the dam. It is estimated that the brook would rise about 1.5 ft. above the stage which was prevailing before the breach, causing additional flood damage to the CEM buildings. Beyond the CEM complex the brook meanders about 1,000 ft. further downstream before joining the Five-mile River. In this reach it is expected that the flood stage caused by a breach of the dam would be considerably reduced and that no further damaging flood flow would occur (see Appendix D, Sheet D-15 which shows the area of potential flooding).

6. Whetstone Brook downstream of Route 12 in vicinity of CEM Co., Inc., buildings.
